**AN ASSESSMENT OF
ABANDONED MINES IN
NORTHERN SASKATCHEWAN
(YEAR 3)**

MAY, 2003

**PREPARED FOR:
SASKATCHEWAN ENVIRONMENT**

Prepared by: Clifton Associates Ltd.
on behalf of
P.A.N.S. Joint Venture

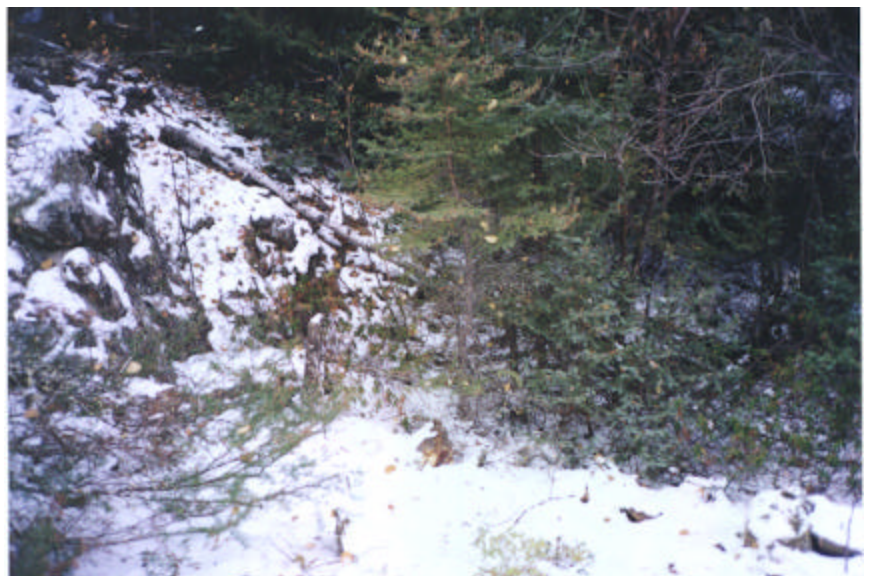
Photograph 6.17-3. Ace Deposit-Trench 'A' at the 'NW Workings'-October 22, 2002.

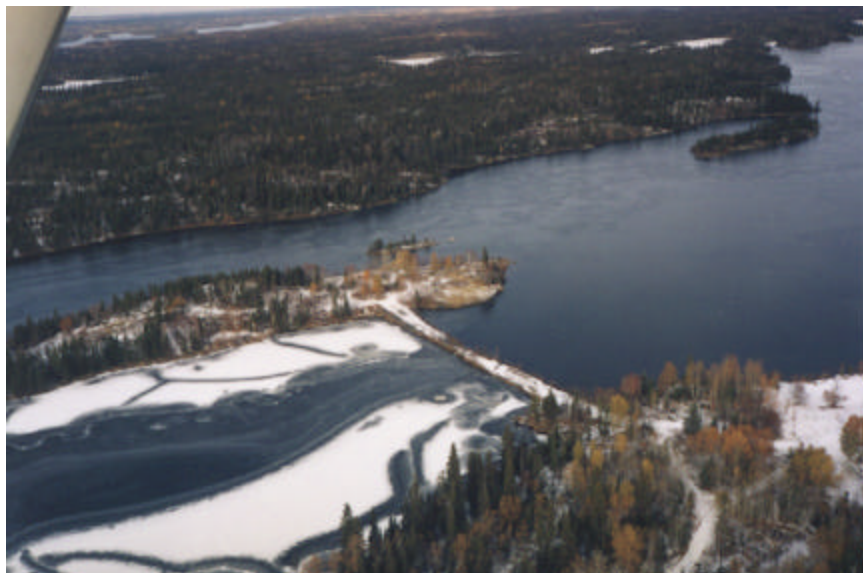
Photograph 6.18-1. Birch Lake Mine-Aerial View-October 23, 2002.

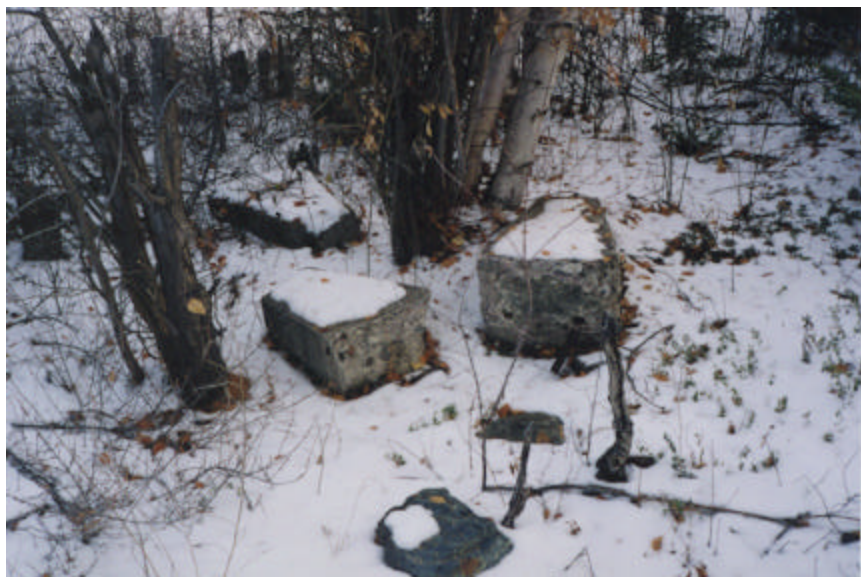
Photograph 6.18-2. Birch Lake Mine-Discarded Concrete Pedestals-October 23, 2002.

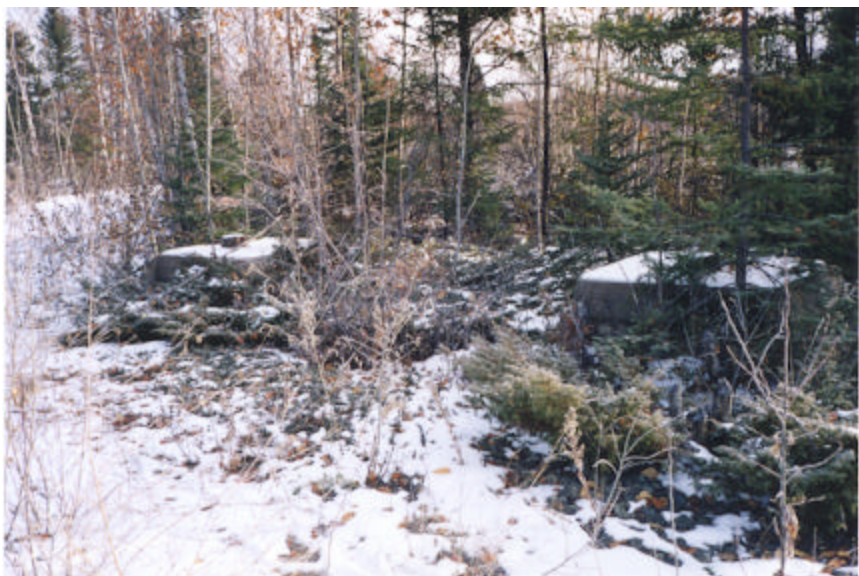
Photograph 6.18-3. Birch Lake Mine-Concrete Footings and Slab for Power Line-October 23, 2002.

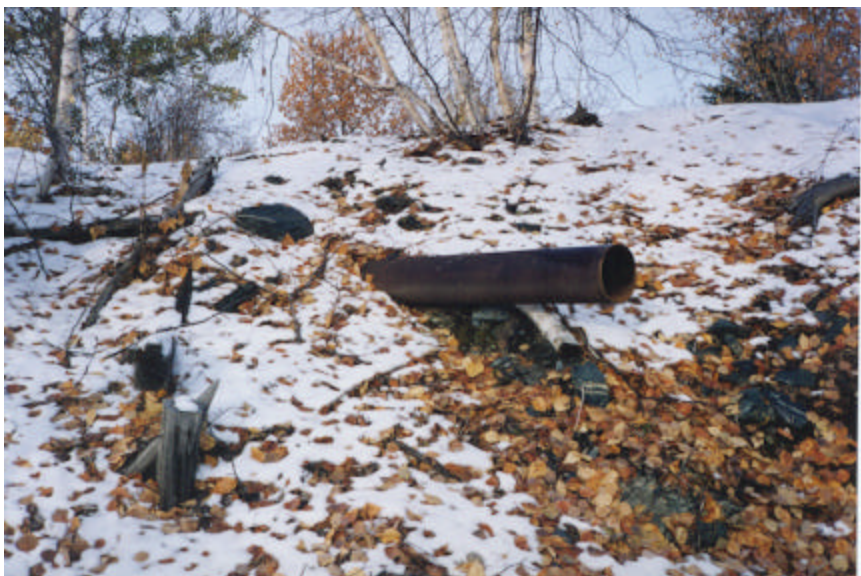
Photograph 6.18-6. Birch Lake Mine-Drainage Pipe-October 23, 2002.

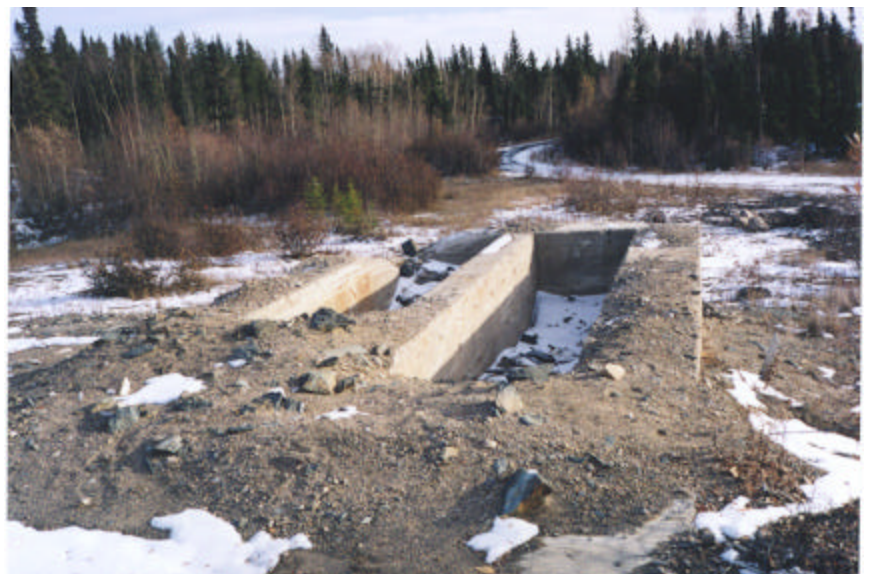
Six concrete foundation ruins, of varying size are located on the site. The dimensions of each ruin are listed in Figure 6.19.3. Ruins 'I' is the largest with 1.2 m high massive footings at one end, and may represent the former headframe. Ruins 'K' is a massive in-ground foundation with two "trench" like 1.2 m deep openings, which may pose a fall-in hazard.

Photograph 6.19-3. Newcor Mine Site
Concrete Ruins-October 24, 2002

Overall, the site does not pose a major public safety hazard since the site has been decommissioned leaving no shaft or other exposed underground openings. Nevertheless, there is a potential safety concern with open trenches beside Douglas Road into which motor and recreational may be driven. The trenches should be backfilled with the available waste rock. The opening at Ruins 'L' should also be filled to eliminate any fall-in hazard. For aesthetic reasons, concrete rubble, scrap lumber and timber and steel should be removed and properly disposed of.

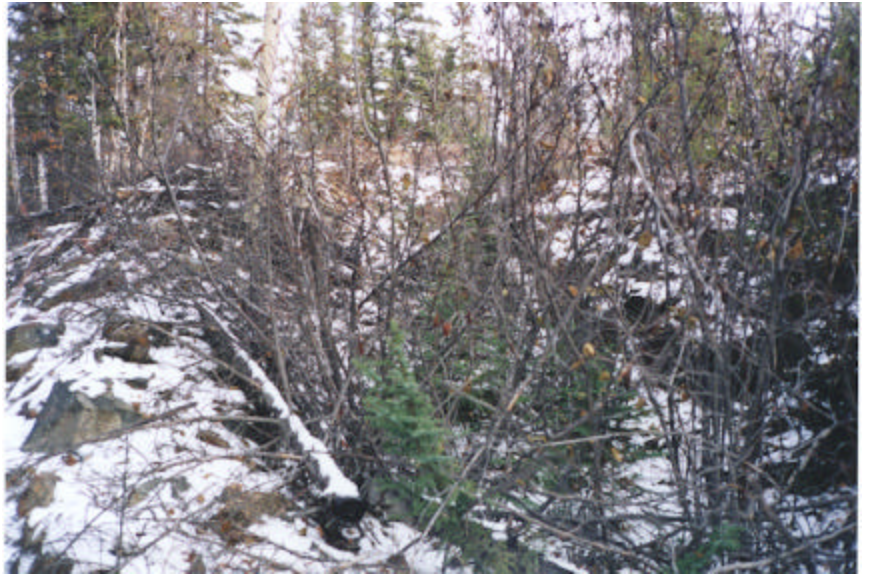
Photograph 6.19-4. Newcor Mine Trench
'M'-October 24, 2002

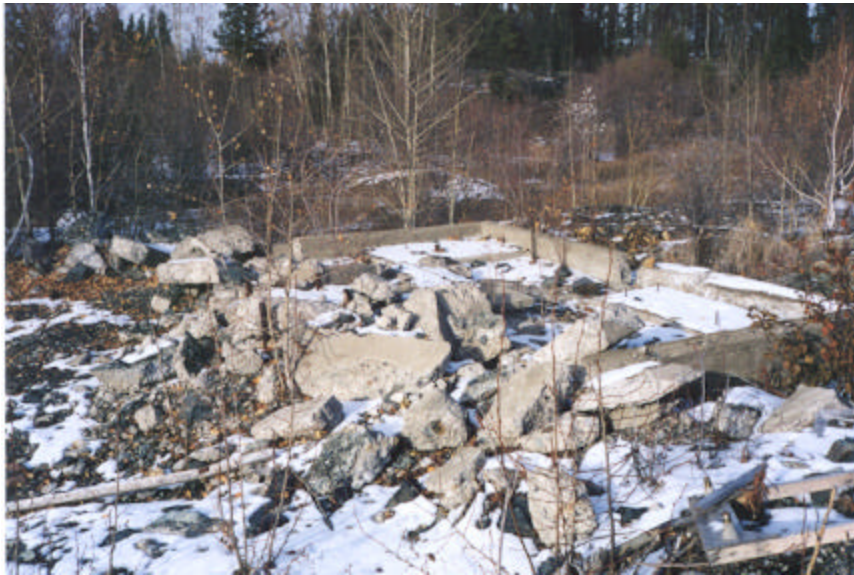
Photograph 6.19-5. Newcor Mine
Site-Concrete Ruins-October 24, 2002

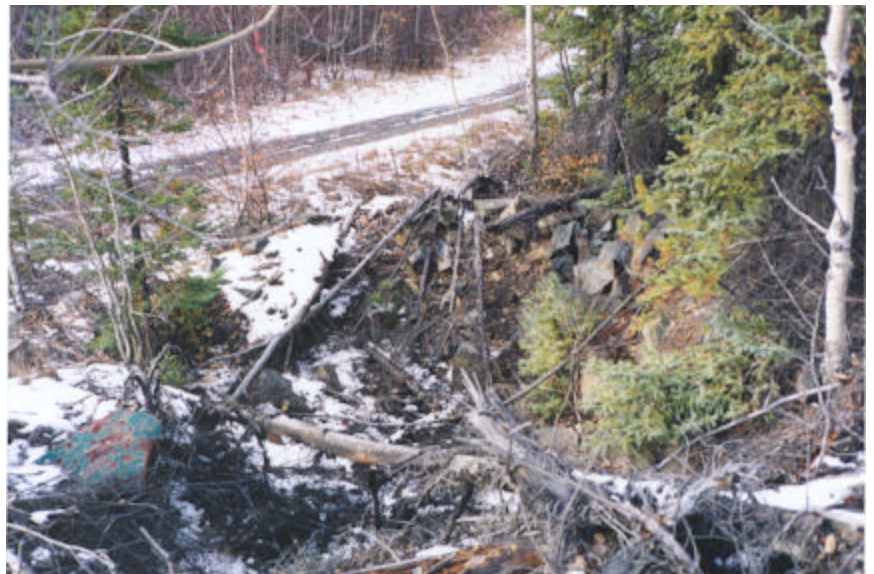
Photograph 6.19-6. Newcor Mine Site
Trench 'N'-October 24, 2002

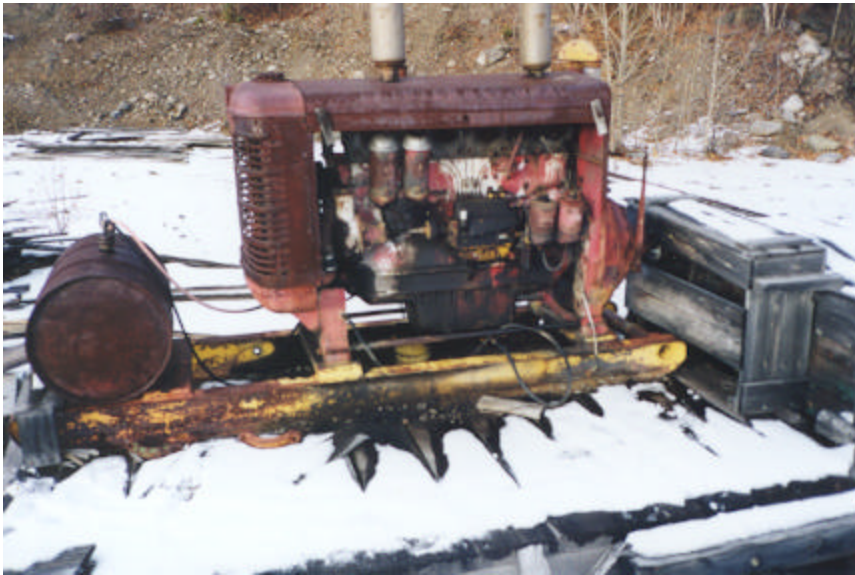
Plastic pails (22-litre capacity), a 70-litre steel barrel and a 205-litre steel barrel have been discarded beside the sawmill motor. Three of the plastic pails contained used hydraulic oil, part of which has spilled and stained the surrounding ground surface. The other six pails were empty. The 70-litre barrel was open and half-filled with rainwater.

Photograph 6.20-2. Flexar Mine-Staining at Sawmill Motor Base-October 23, 2002

Overall, the site does not pose a public safety hazard since the site has been decommissioned leaving no shaft or other exposed underground openings. The extent of the hydrocarbon fuel and lubricant impact to the subsurface immediate to the sawmill motor may need to be assessed. For aesthetic reasons, the sawmill equipment and scrap materials should be removed and disposed of properly.

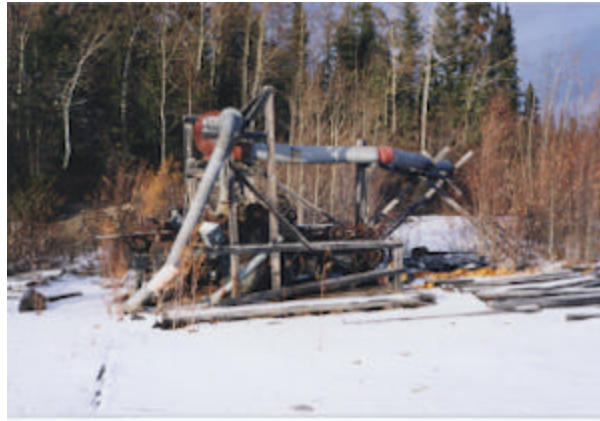
There is a large amount of debris scattered about the site. Debris from the former sawmill operation includes the sawmill platform and motor, a wood planar, and small piles of cut lumber and logs. A half-full 205-litre steel fuel barrel remains attached to the motor. Dark staining was evident at the base of the motor and on the wood platform, and appears to have been from the leaks or spills of lubricating oil or fuel.

Photograph 6.20-7. Flexar
Mine-Abandoned Wood Planar-October
23, 2002

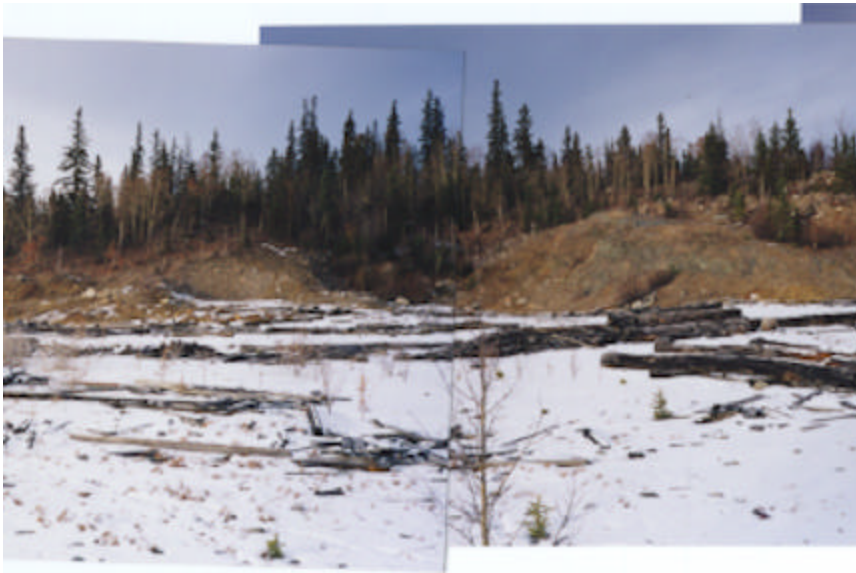
Waste rock covers the 100 m by 100 m site to an unknown depth, has been graded level, and does not present a public safety hazard. The depth of waste rock may be shallow since bedrock outcrops are visible at the northwest end of the site. Based on an average depth of 1 m, the total volume of waste rock likely exceeds 10,000 m³. It is not known if the waste rock extends into the adjacent lake, however, more than 270,000 tonnes of ore was mined which should result in more waste rock at the site than was observed.

Photograph 6.20-8. Flexar
Mine-Panoramic View of Former Minesite
Looking North-October 23, 2002

Given the high acid generation potential of the waste rock, efforts should be made to consolidate the waste rock and construct surface diversion works so that runoff is directed away from nearby water bodies.

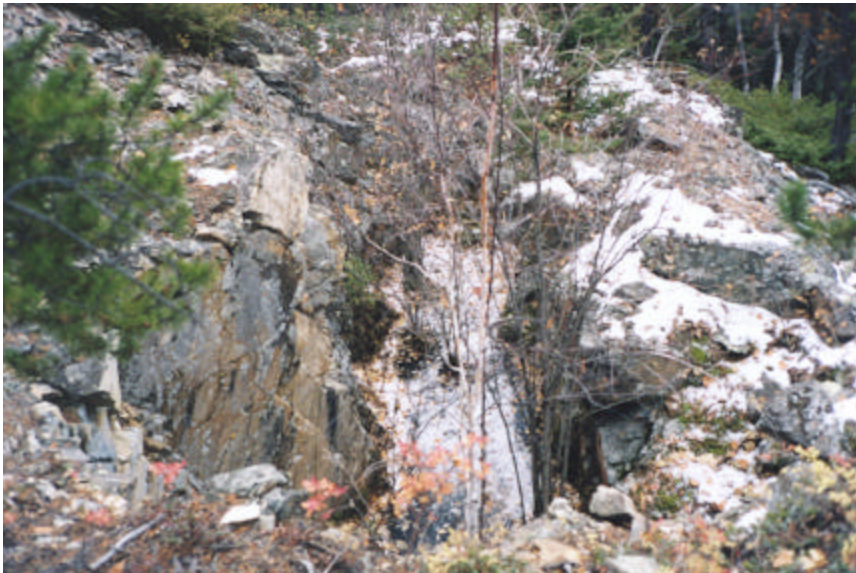
Photograph 6.22-2. Lucky Strike Mine-Trench 'C'-October 24, 2002

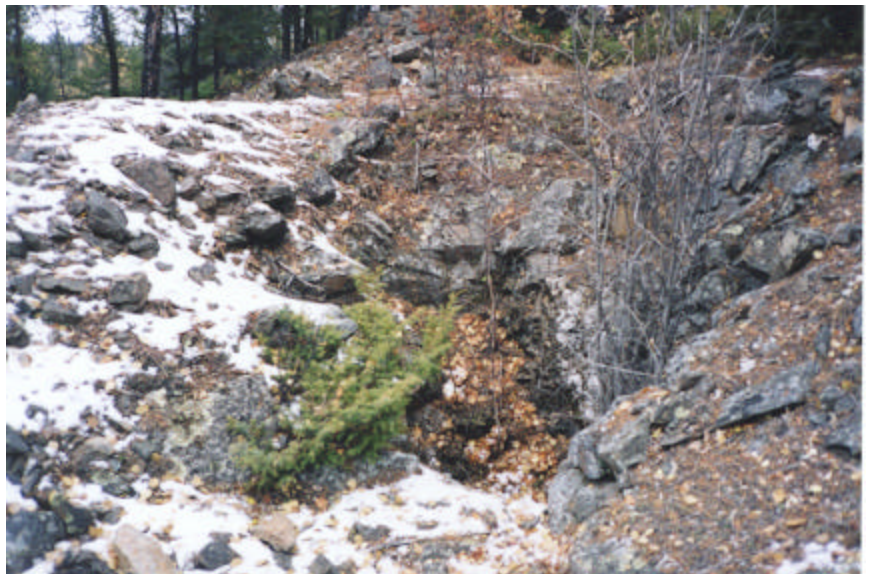
Mine workings at the Lucky Strike Showing consist of a prospect shaft, four rock trenches and a shallow pit. Figure 6.22-2 shows the measured dimensions of each excavation. The shaft is 1.5 m deep and flooded. Timber shoring remains in place along the shaft walls. Moss and soil overhangs the lip of the shaft opening. The trenches are variable in length (1.5 m to 6.7 m) with a depth (0.6 m to 2.1 m). The sloped trench walls are stable, scrub vegetation grows along the edges, and a minor amount of frozen precipitation water had pooled in the bottom of the trenches. The trenches do not pose a serious public safety due to their relatively shallow depths, open visibility, and distance from the shoreline, however, there is a trip / fall-in hazard associated with the prospect shaft. Large animals may not be able to escape from the prospect shaft, if they accidentally fall into it.

Photograph 6.22-4. Lucky Strike Mine-Shaft Area'-October 24, 2002

Closure of the prospect shaft should be considered, even though public visitation to the site is unlikely due to its distance and location from the shoreline. The waste rock beside the shaft could be hand-shoveled into the opening thereby reducing any fall hazard. The other trenches and pits are relatively shallow, easily recognizable when approached, and thus public safety is not a concern.

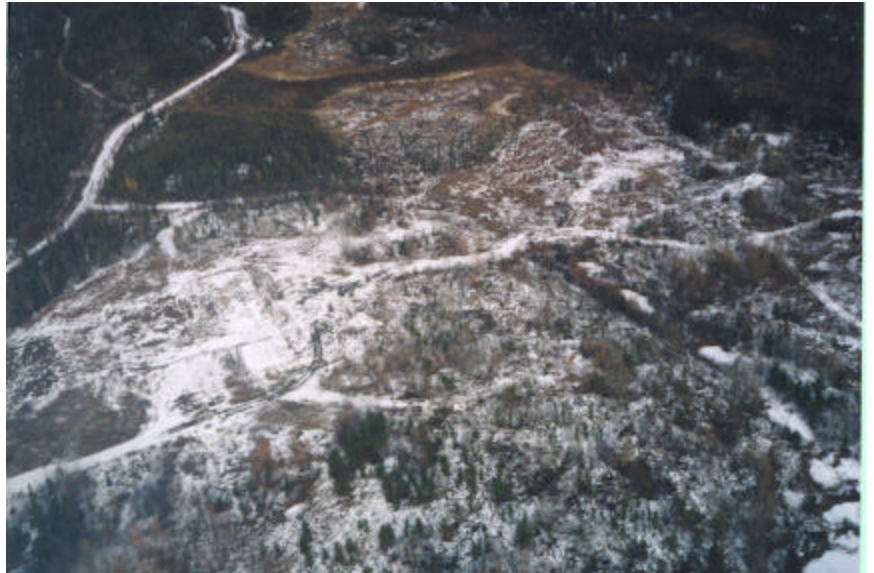
Photograph 6.23-2. Vista (Bootleg)
Mine-Aerial View of Tailings Area-October
23, 2002

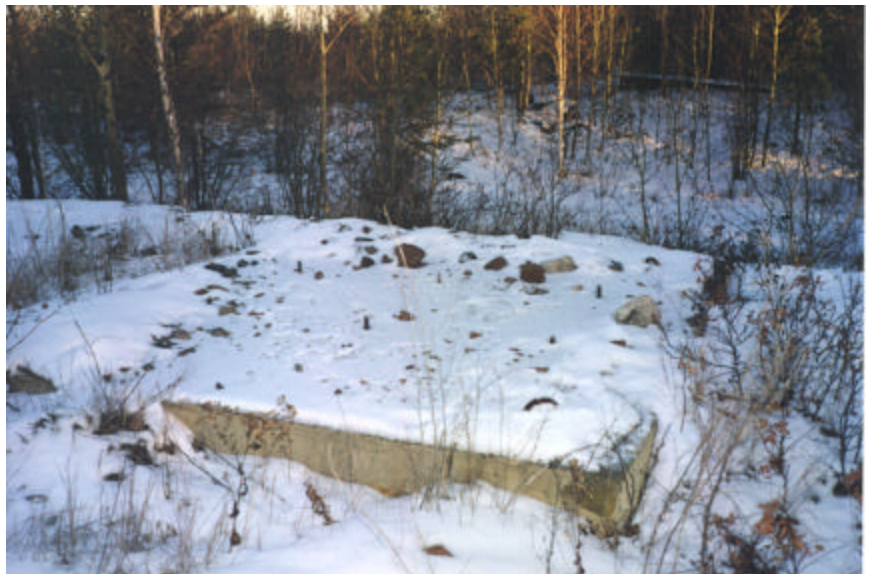
Photograph 6.23-7. Vista (Bootleg)
Mine-Scrap Steel Plate-October 29, 2002

Follow-up activities should be directed at removing fall hazards. Finer crushed rock can be placed on top the pile covering the decline entrance to close the rock gaps. The prospect shaft can be backfilled with waste rock. Debris, such as the refrigerator and scrap metal, can be removed for appropriate disposal.

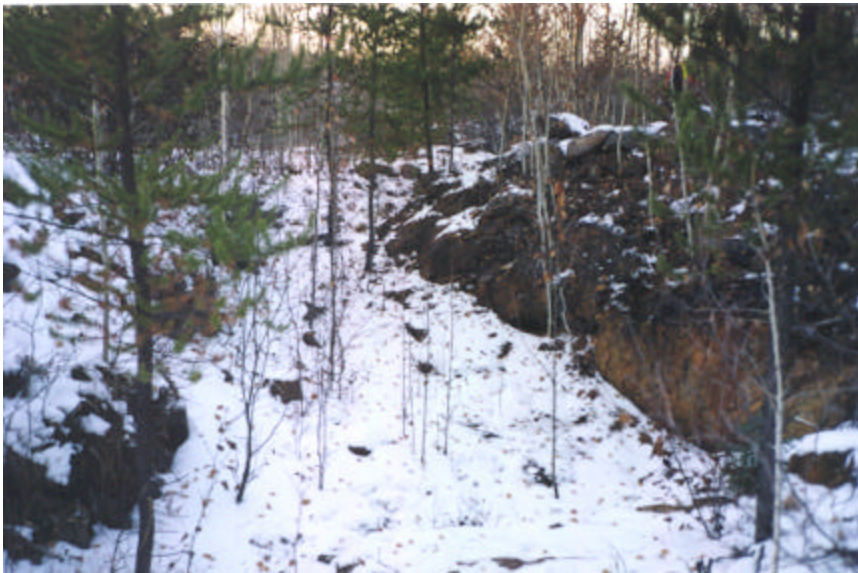
Photograph 6.23-9. Vista (Bootleg)
Mine-Waste Rock Covering Decline
Entrance-October 29, 2002

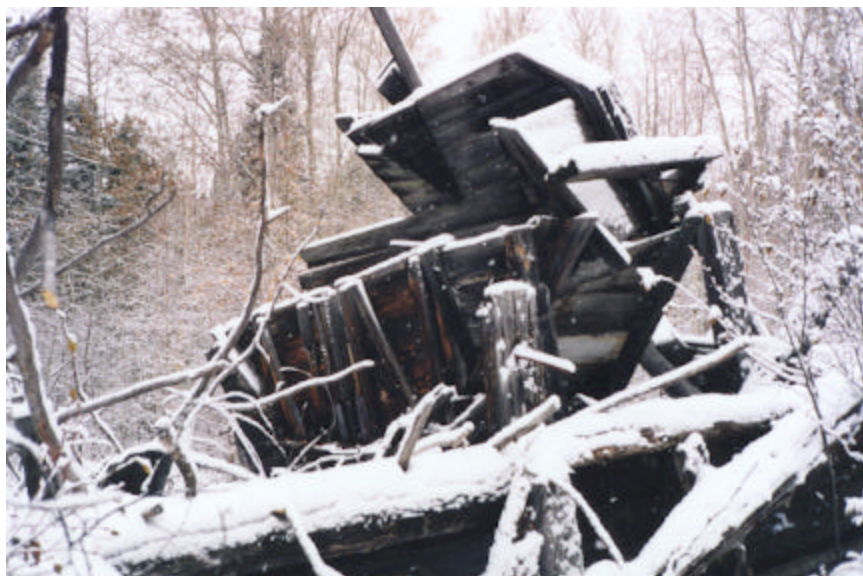
Photograph 6.24-7. Graham Mine-Discarded Machiner at No. 2 Deposit-October 25, 2002.

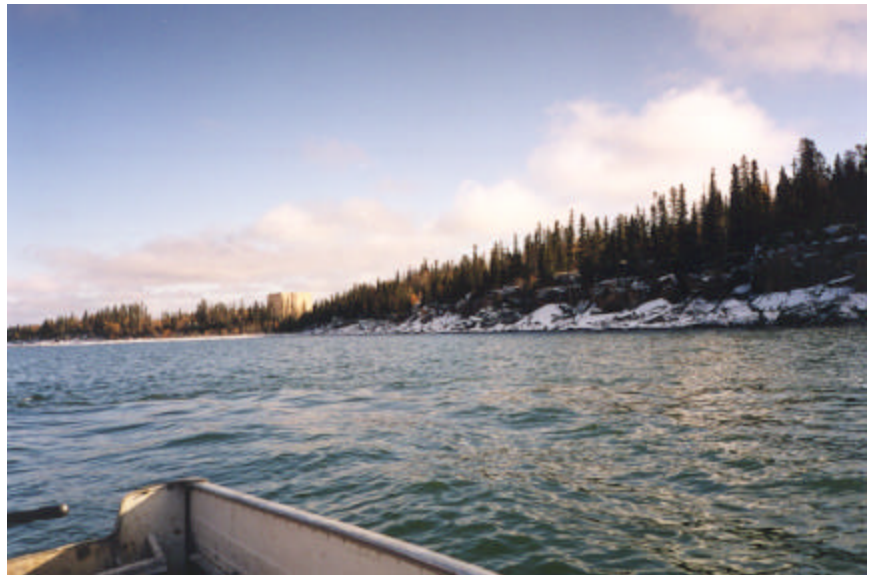
Photograph 6.25-1. Namew
Lake-Shoreline on Manitoba Side-October
26, 2002

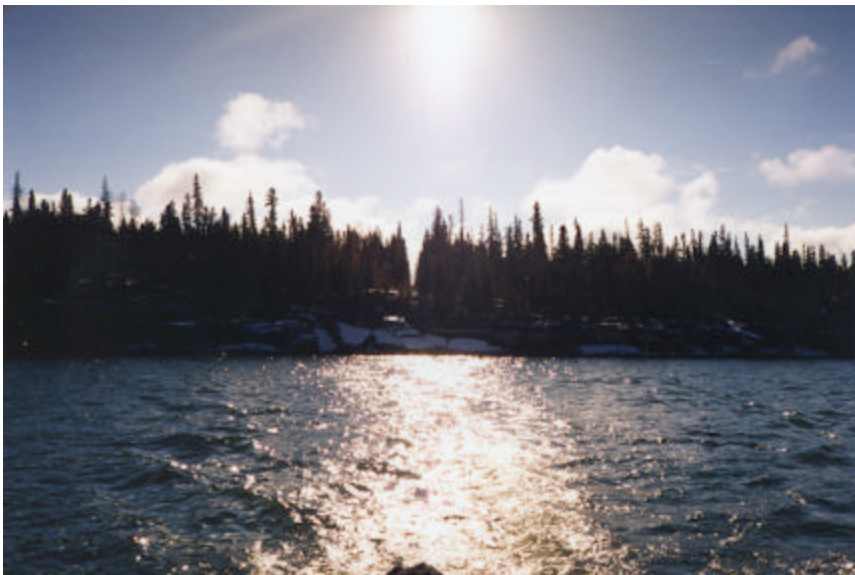
Photograph 6.25-2. Namew
Lake-Saskatchewan/Manitoba Provincial
Boundary Cut-Line-October 26, 2002

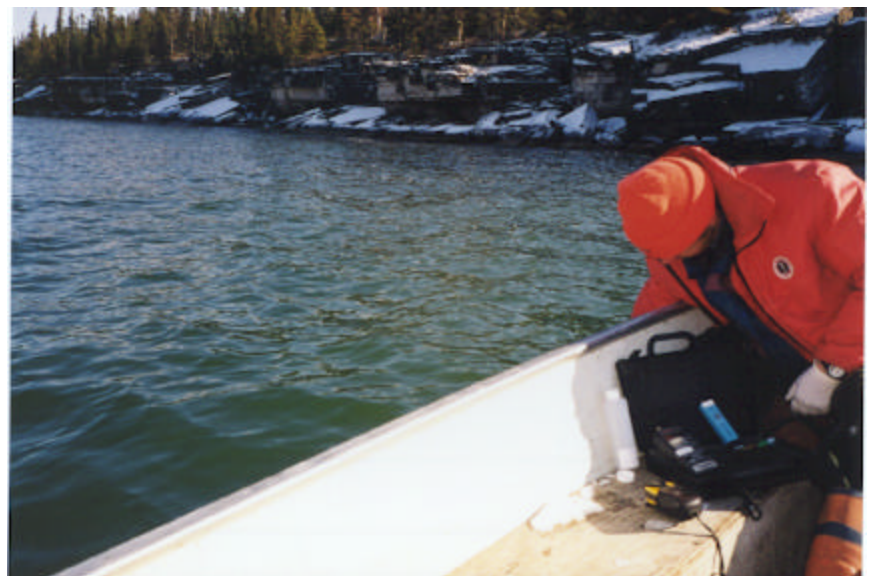
Photograph 6.25-3. Namew
Lake-Collecting Water Sample-October
26, 2002

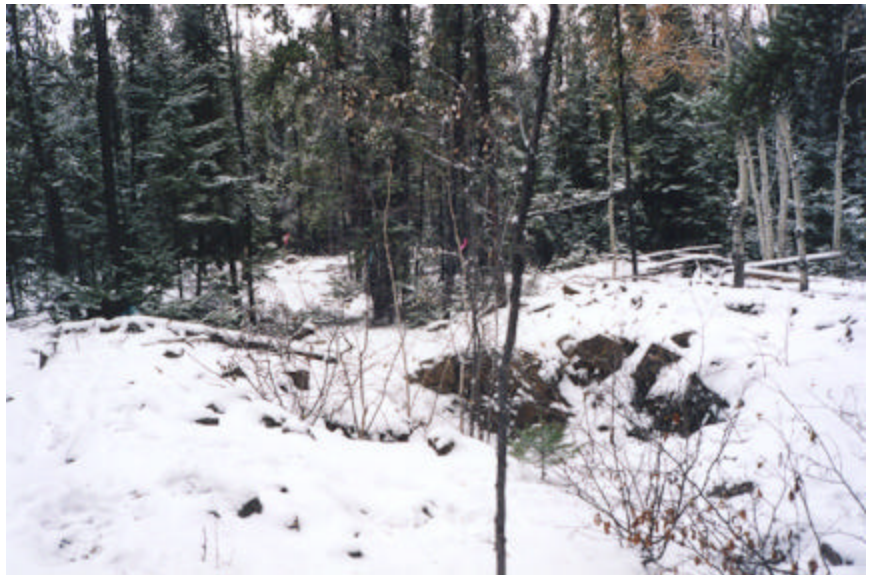
The No. 1 Workings (name assigned for this investigation) are the largest, and consist of four rock pits and a smaller rock cut. Pit dimensions are generally 3 m x 1.8 m to 2.4 m and 1.8 m deep. Ice was observed at the bottom of each pit, and is likely accumulated precipitation. Walls of the excavations appear solid and stable, although there appears to be some soil overhang at edges.

Photograph 6.26-1. Phantom Lake
Mine-No. 1 Working Area
Overview-October 27, 2002.

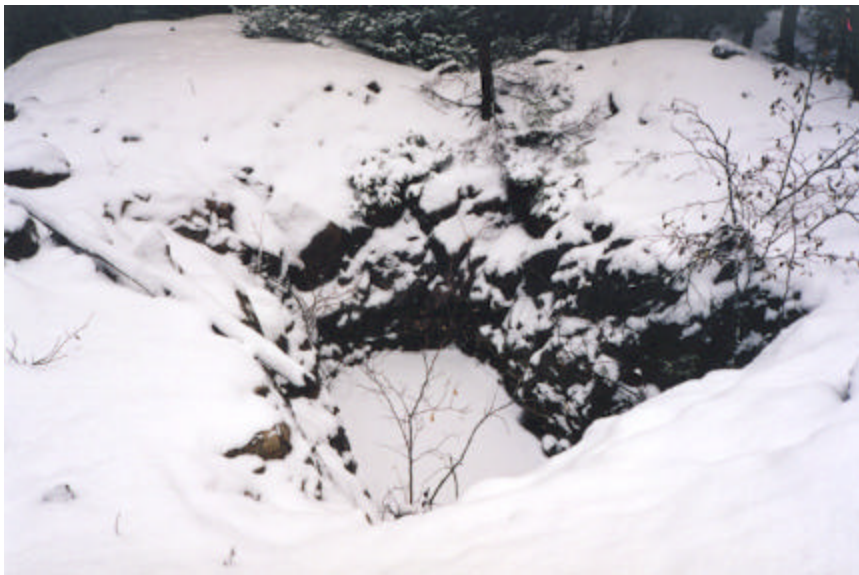
Photograph 6.26-2. Phantom Lake
Mine-No. 1 Workings Pit 'C'-October 27,
2002.

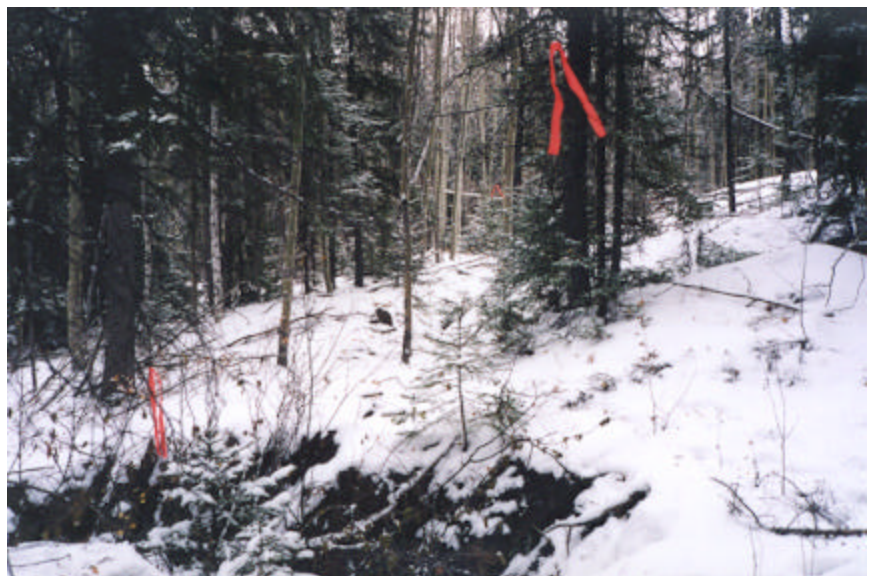
Photograph 6.26-3. Phantom Lake
Mine-No. 2 Workings Trench 'A'-October
27, 2002.

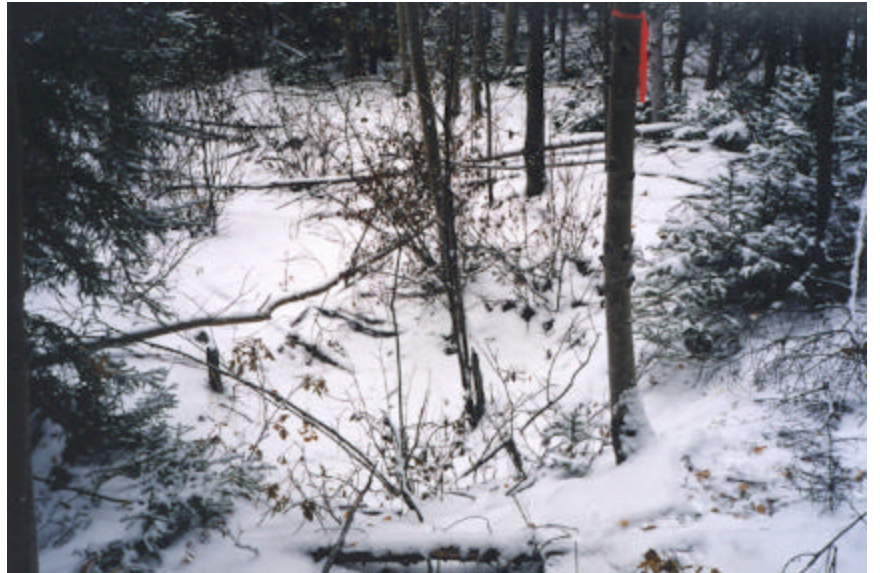
Photograph 6.26-4. Phantom Lake
Mine-No. 3 Workings Overburden
Trench-October 27, 2002.

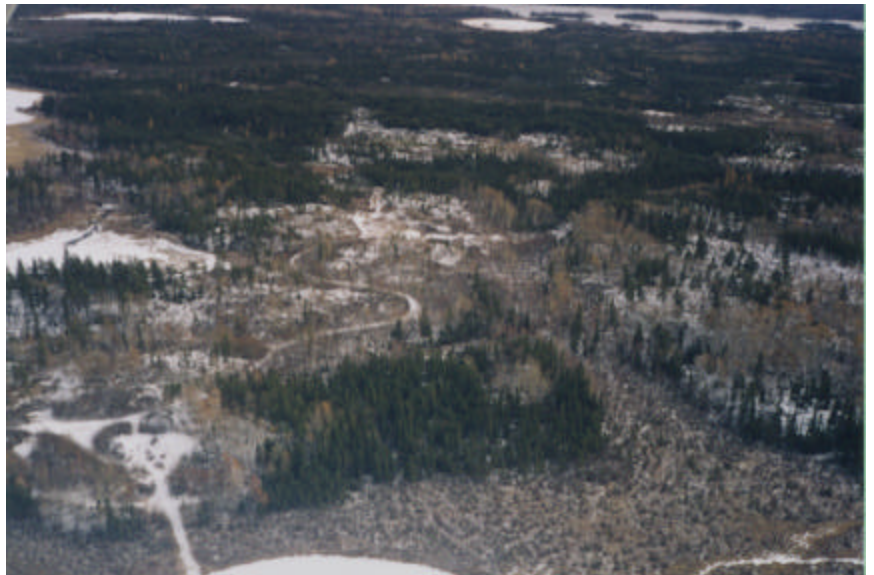
Photograph 6.28-1. Henning Maloney Mine-Aerial View-October 23, 2002.

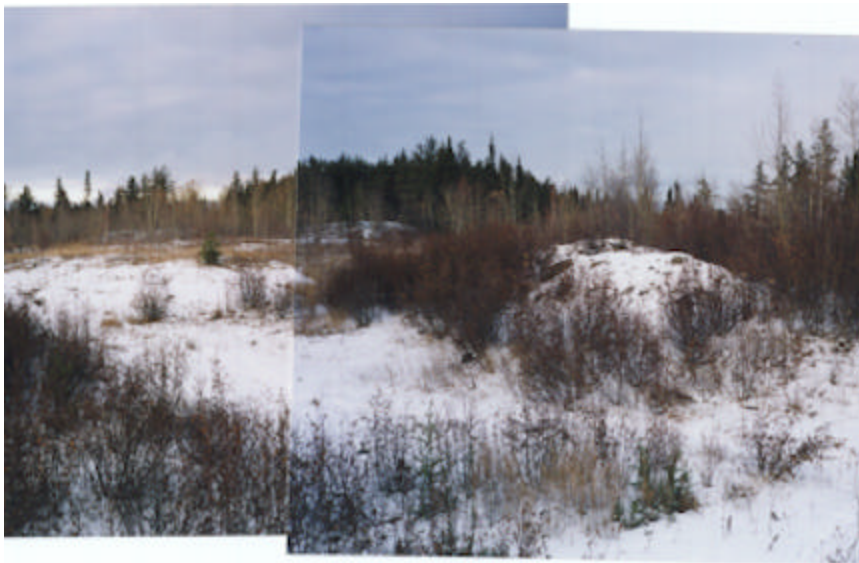
Photograph 6.28-2. Henning Maloney Mine-Overview of Site Showing Waste Rock Pile-October 27, 2002.

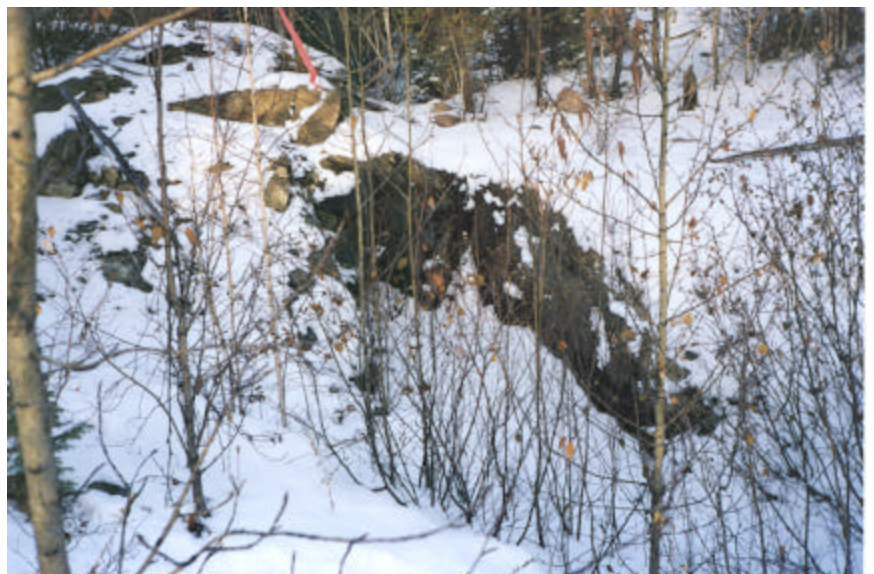
Photograph 6.28-3. Henning Maloney Mine-Trench 'A'-October 27, 2002.

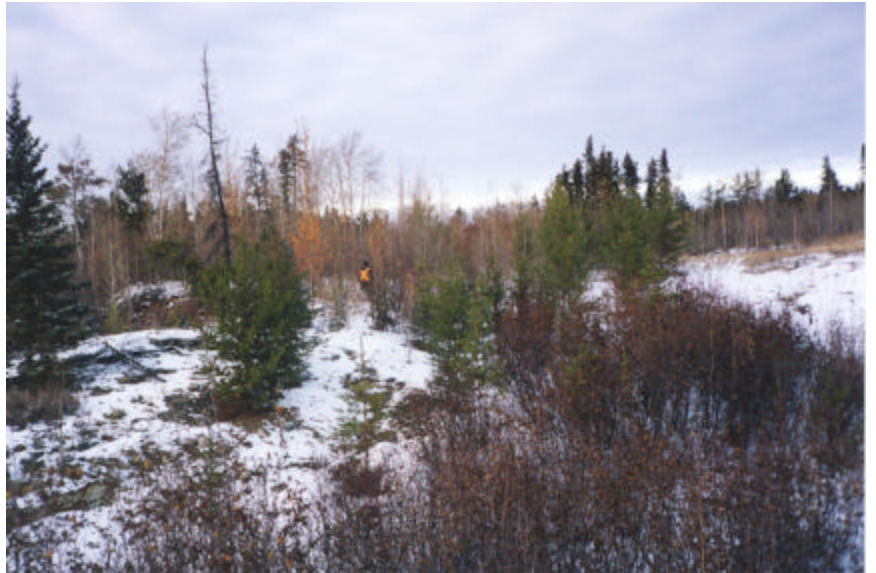
Photograph 6.28-4. Henning Maloney
Mine-Debris-October 27, 2002.

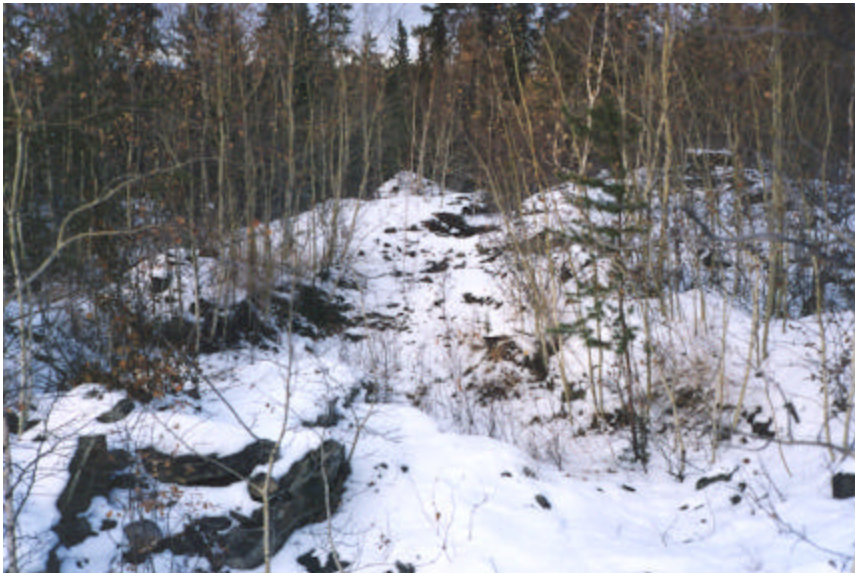
Photograph 6.28-5. Henning Maloney
Mine-'Trench 'B'-October 27, 2002.

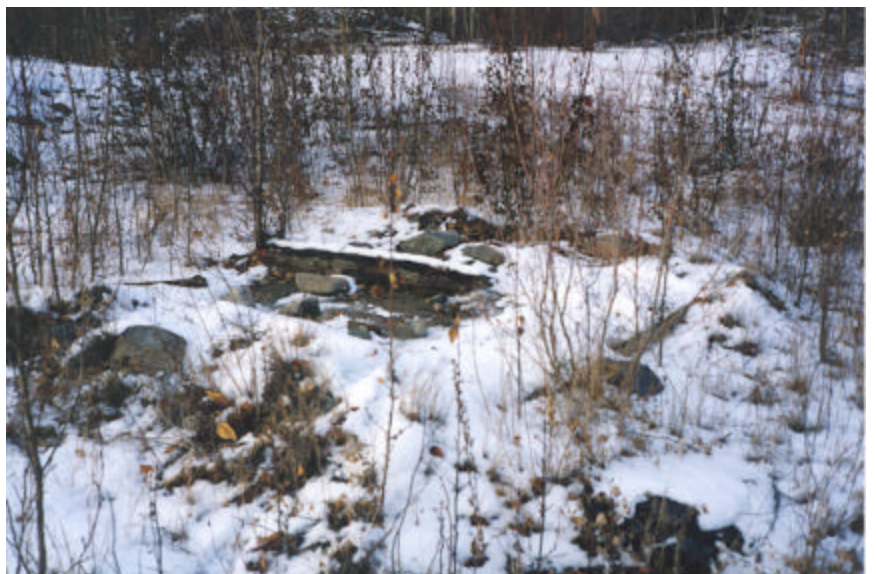
Photograph 6.28-6. Henning Maloney
Mine-Concrete Pad-October 27, 2002.

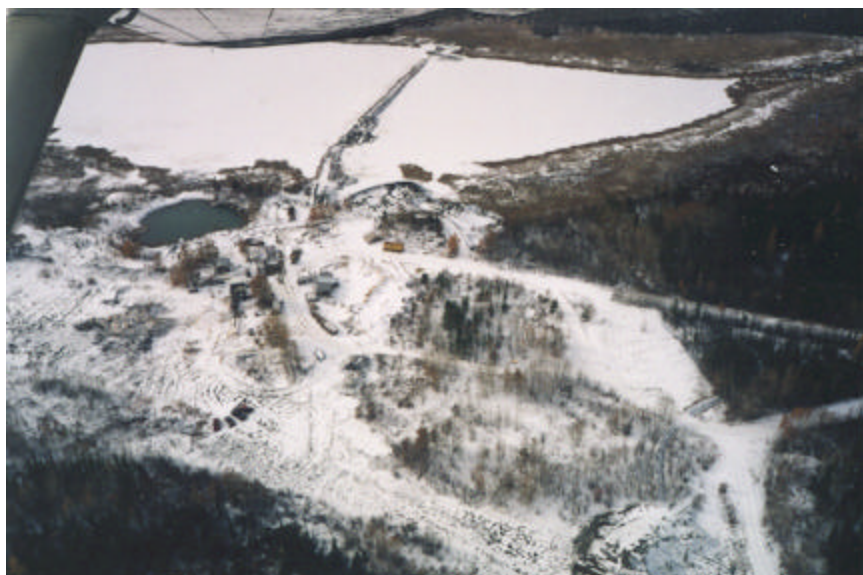
Photograph 6.29-1. Coronation Mine-Aerial View-October 23, 2002.

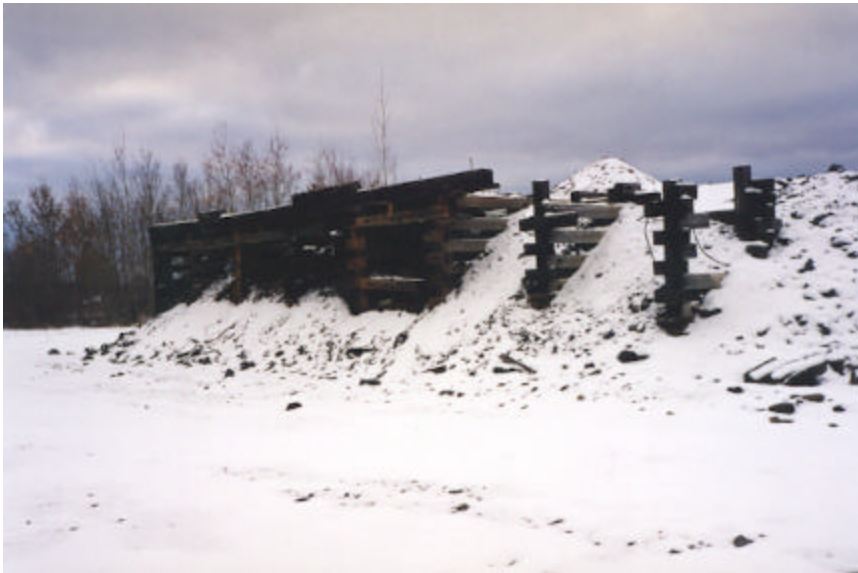
Photograph 6.29-8. Coronation Mine-Loading Platform-October 28, 2002.

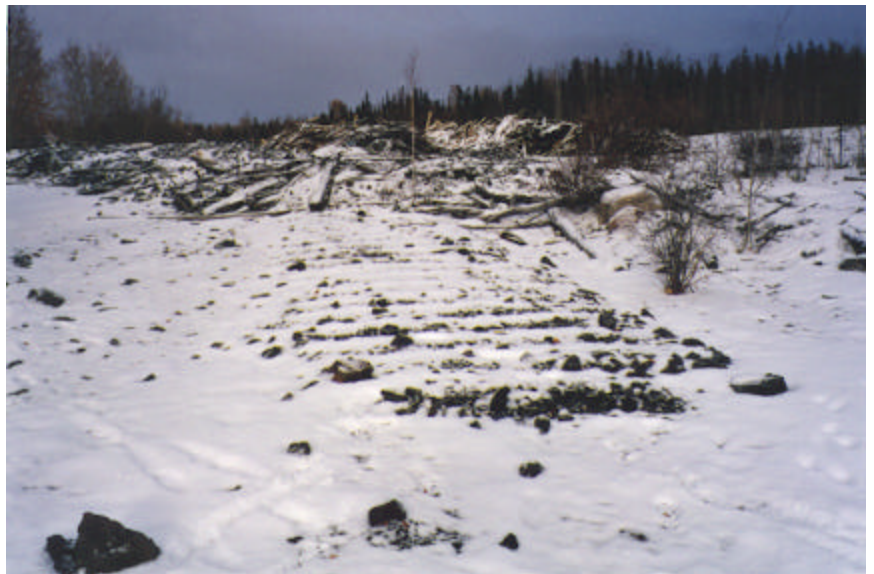
Photograph 6.29-9. Coronation Mine-Remnant Railway Trackbed-October 28, 2002.

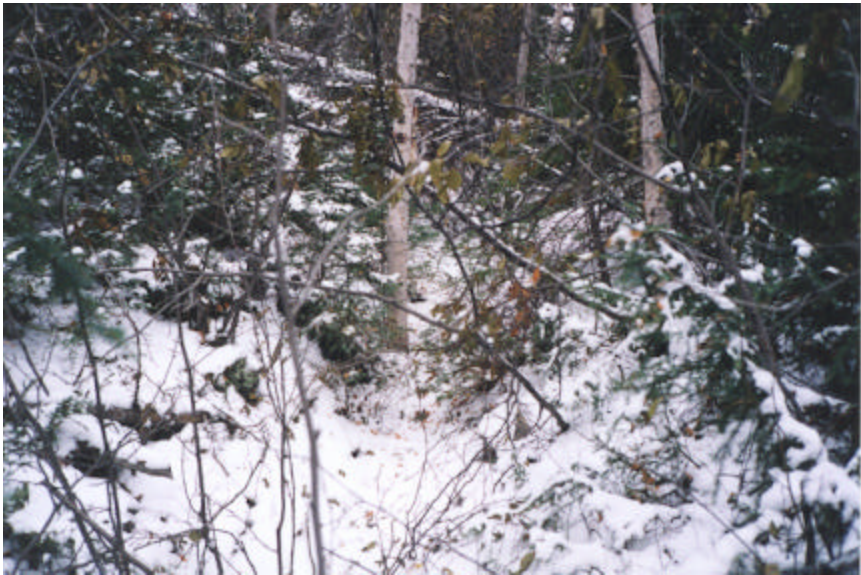
Photograph 6.30-2. Wekatch Gold Mines-Shaft-October 28, 2002

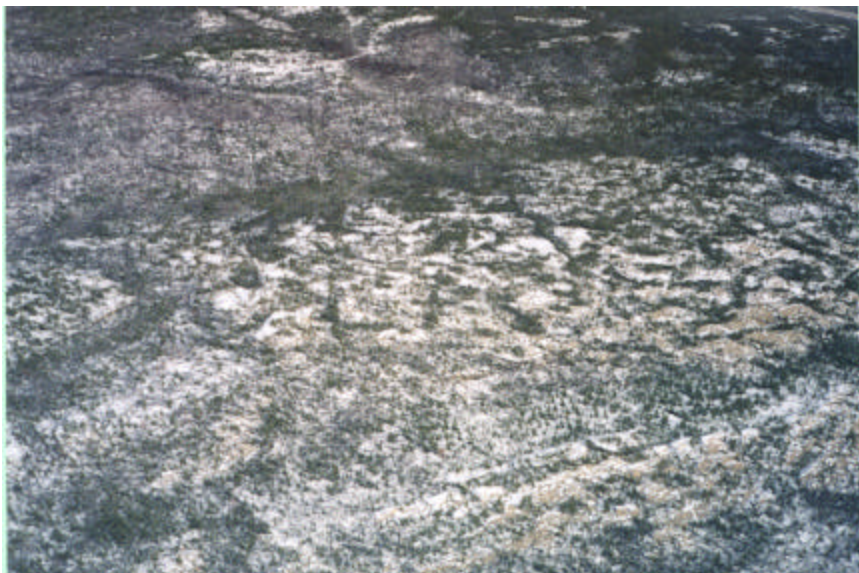
Photograph 6.31-1. CAM Option Copper
Showing-Aerial View-October 23, 2002

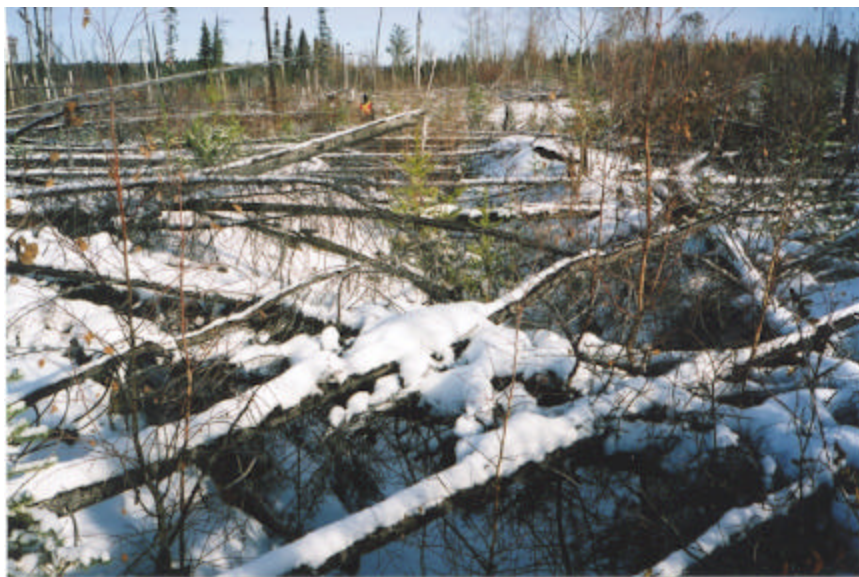
Photograph 6.31-2. CAM Option Copper
Showing-Trench No. 6-October 29, 2002.

Consideration should be given to infilling the trenches since they could pose a public safety risk to users of ATVs and snowmobiles. Waste rock at the trench edges could be back-filled into the trench by bulldozer.

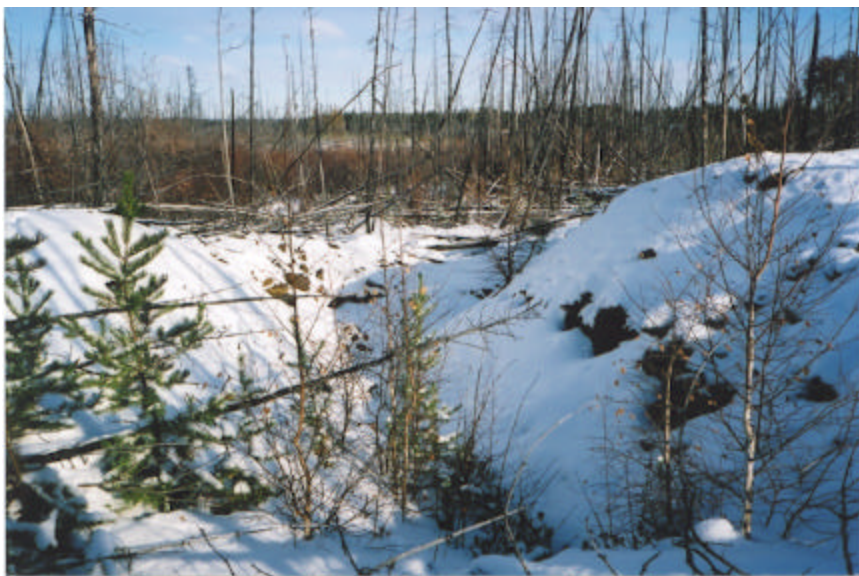
Photograph 6.31-3. CAM Option Copper
Showing-Trench No. 7-October 29, 2002.
